The Features of Tateyama Sabo and their Value

PII-38

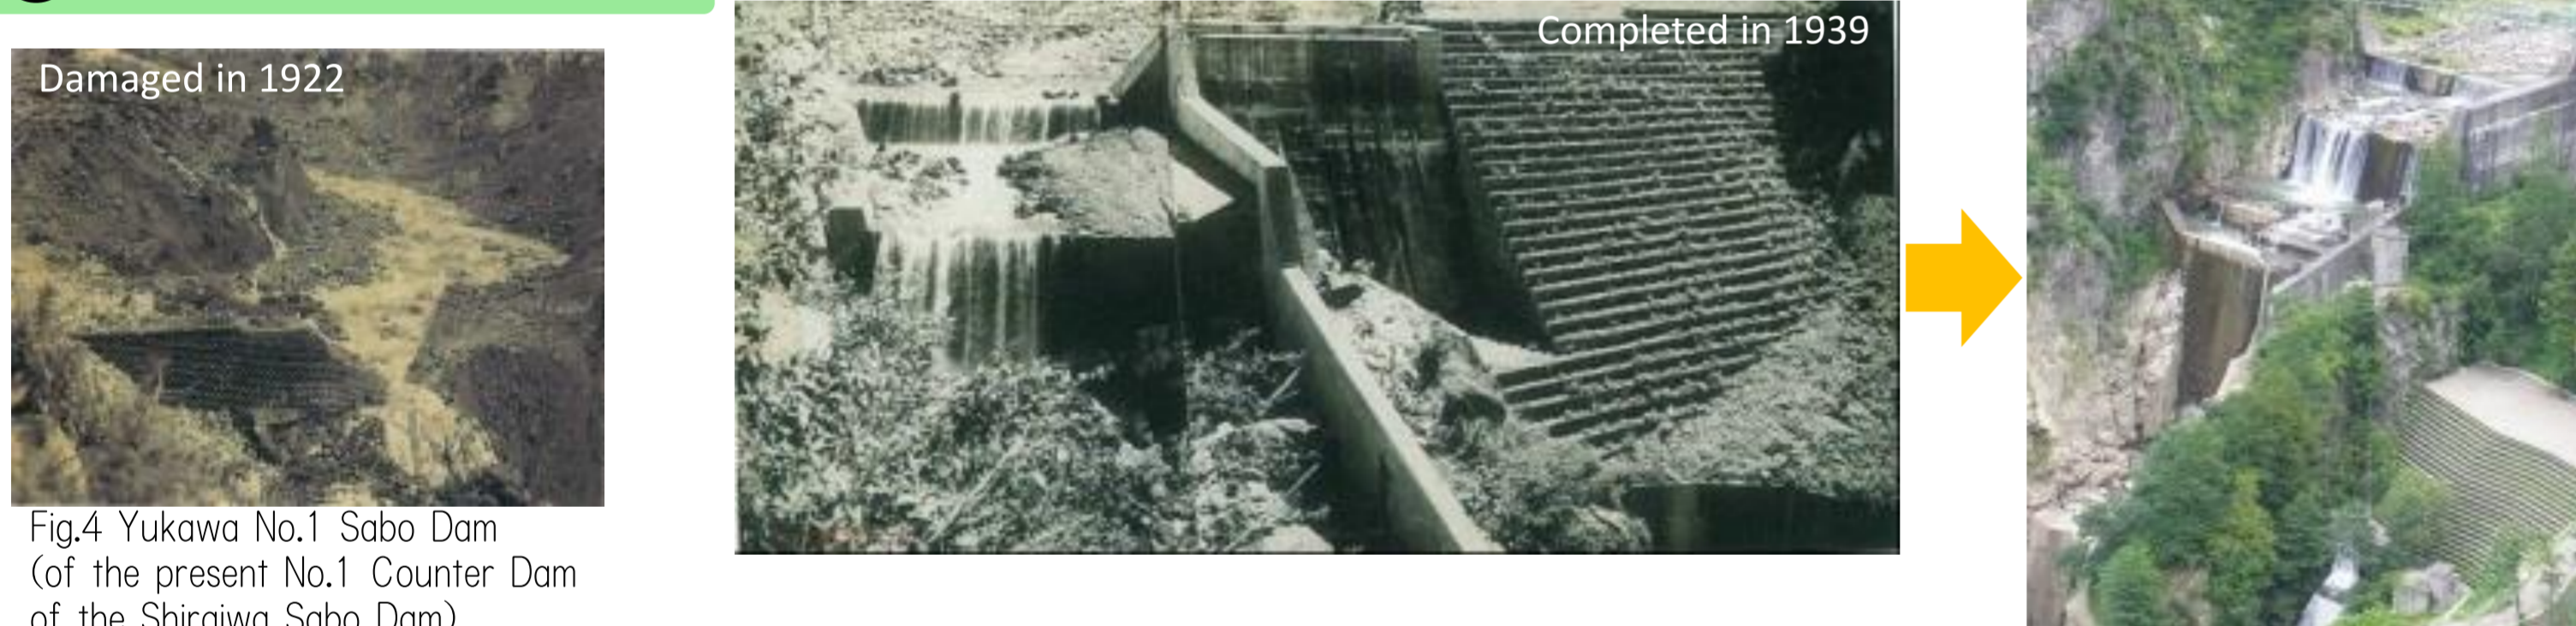
Fig.4 Yukawa No.1 Sabo Dam (Of the present No.1 Counter Dam of the Shiraiwa Sabo Dam)

Fig.5 Changes of The Shiraiwa Sabo Dam

The Shiraiwa Sabo Dam is located at the outlet of the Tateyama Caldera on which collapsed earth and sand accumulated. It is the core check dam of the "Overall Sabo Plan for the Joganji" designed by Akagi Masao, who is well known in Japan as the "Father of Modern Sabo Works", to raise the eroded riverbed, thus stabilizing the Tateyama Caldera and preventing sediment discharge. Construction was started in 1929 by the Tateyama Sabo Office of the former Home Ministry and completed in 1939. It is a representative Japanese sabo facility; The main dam is the highest sabo facility in Japan. It has a special composite structure, combining a gravity dam and an earth-filled embankment dam covered with the concrete-bar square frames. In consideration of the 1858 large earthquake, it was constructed using a seismic design method. It is a structure of high academic value and a system that demonstrates the technical advancement of a modern sabo facility.

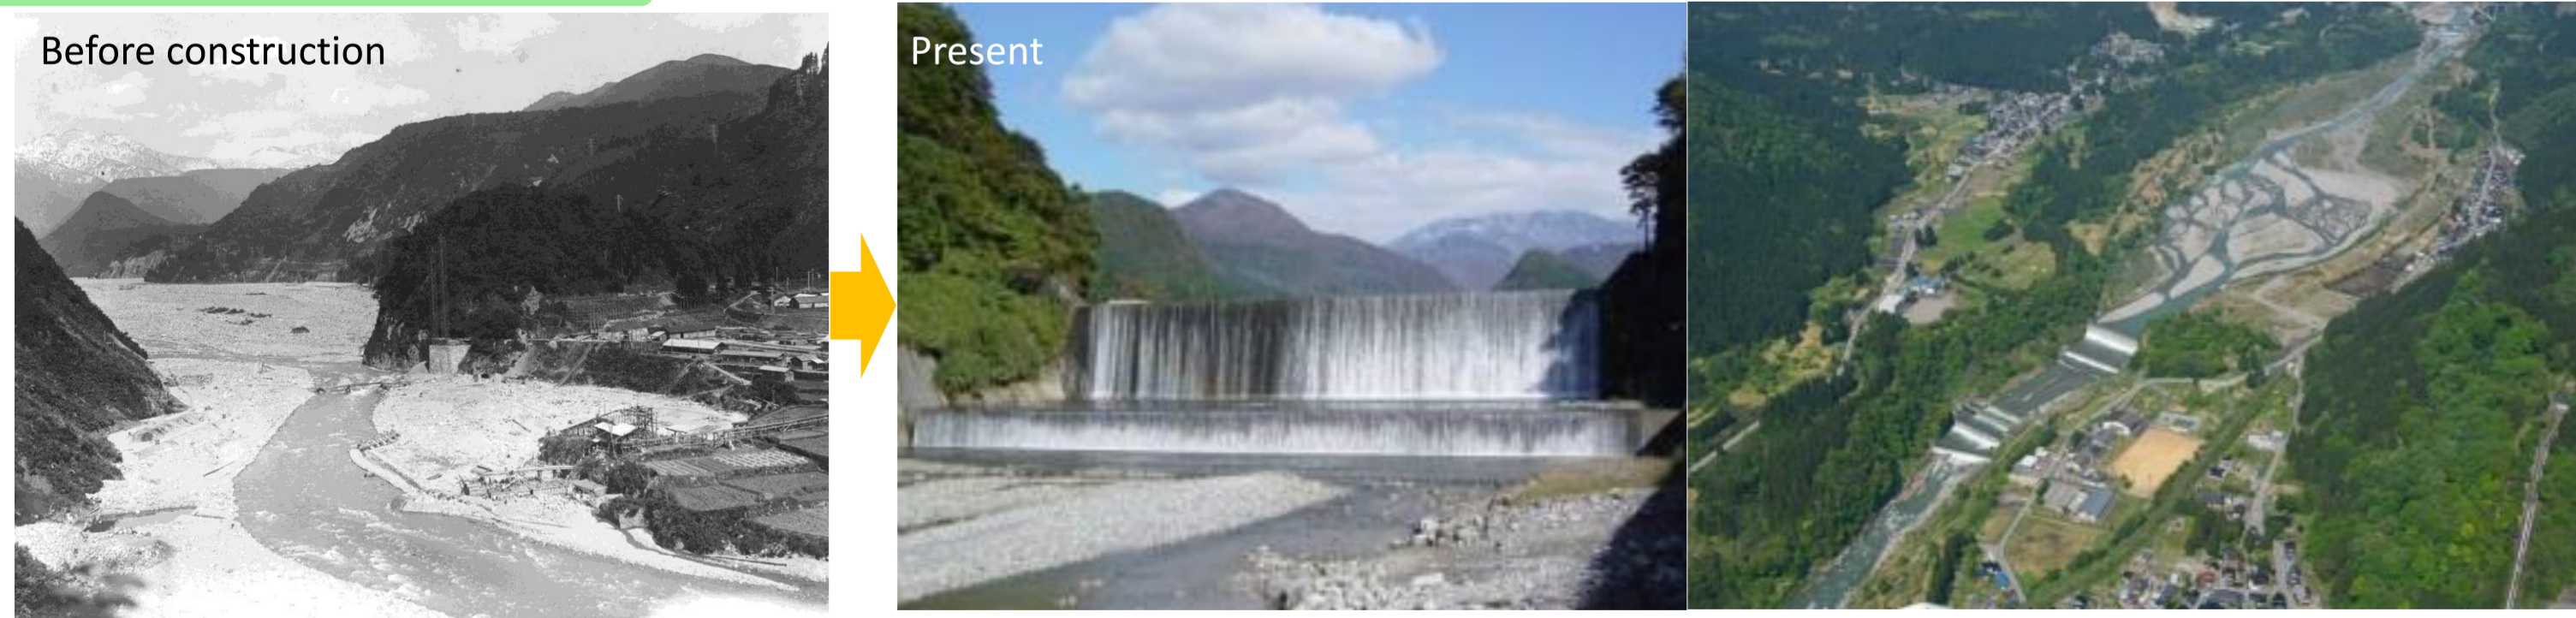
Fig.6 Changes of The Hongu Sabo Dam

The Hongu Sabo Dam is a large-scale sabo dam constructed in the midstream of the Joganji River for sediment storage. Its construction was started in 1935 and completed in 1936. It was constructed by the Joganji River Dam Office of the former Home Ministry as part of the Joganji River Improvement Project. Construction of this dam was regarded as pre-work for the river improvement in the downstream and its primary purpose was to store sediment flowing from the upstream. The sediment-trapping capacity ($5.0 \times 10^6 \text{ m}^3$) is the largest of all dams in Japan.
